Protective Coating and Repair System for Potable Water Contact

Belzona 5812DW is an NSF (ANSI 61) certified coating for metallic and non-metallic surfaces in contact with aqueous solutions.

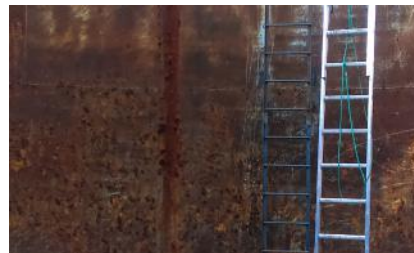
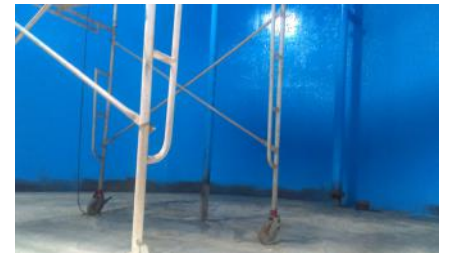
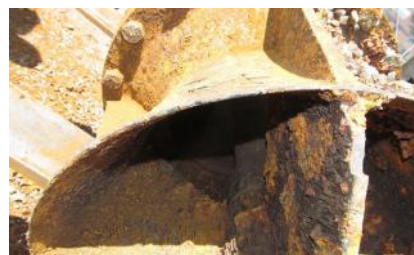
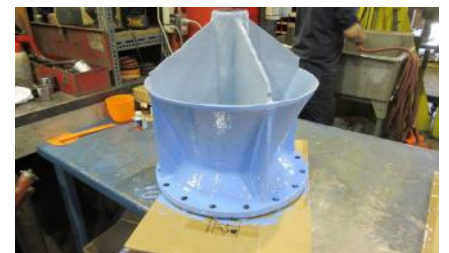
Before and After:

Before

After
